FORM 8-K

Astra Space, Inc.
(Exact name of Registrant as Specified in Its Charter)

Conclusion of TROPICS-1 Mishap Investigation

By Andrew Griggs, Head of Mission Assurance, and Adam London, Founder and Chief Technical Officer

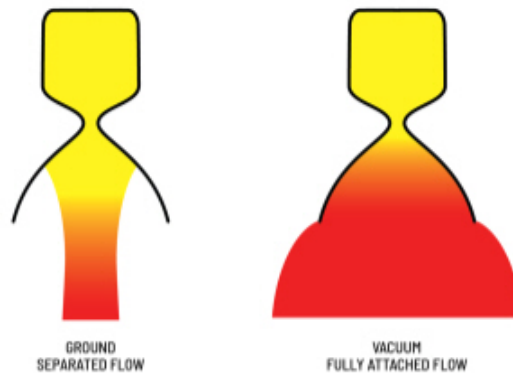
So, we were left with gaseous fuel as the main suspect. During ground acceptance testing, the fuel in the upper stage engine gets warm but we had never observed boiling or near-boiling within the cooling channels. However, the exhaust jet of the upper stage engine on the ground is “separated” from the inside of the engine nozzle by the pressure of the atmosphere around it, and therefore transfers less heat into the fuel. In flight, the engine is surrounded by vacuum and the exhaust jet expands to become “fully attached” to the inside of the nozzle. Therefore, the fuel passing through the engine during flight is heated to a higher temperature than during ground testing.

CAPTION: Comparison of (ground) separated rocket engine flow vs (vacuum) fully-attached rocket engine flow

We conducted numerous experimental engine tests with fuel pre-heated to various temperatures to simulate the effect of full attachment. This allowed us to create a more sophisticated thermal model to predict the temperature of the fuel inside the engine with better accuracy than before. This analysis showed that, in flight, the fuel at the injector would have thin margins with respect to its boiling point. The most significant contributors to this thin margin were unique to the Rocket 3 architecture: a pressure-fed upper stage engine that operates at relatively low pressures, as well as the selection of a kerosene-like fuel with a higher vapor pressure than traditional rocket-grade kerosene (e.g. RP-1) to simplify testing and operations.

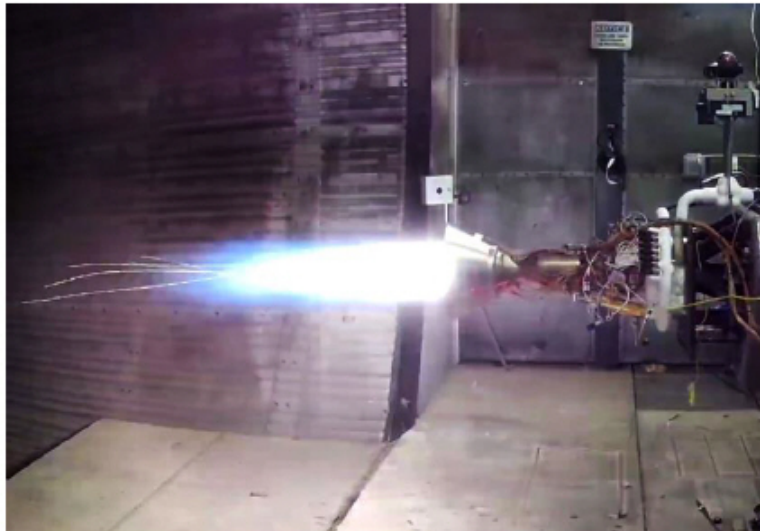
Given this thin margin, small factors - like the warm sunny weather in Cape Canaveral on the day of launch, which meant the fuel was slightly warmer than in prior flights - helped to tip the fuel over into a boiling regime on the TROPICS-1 mission. Our analysis has concluded that the boiling fuel caused the partial injector blockage in flight and, together with the eroded thermal barrier coating mentioned previously, caused a thermal “run-away” event that worsened the injector blockage and eventually led to the burn-through.

CAPTION: Upper stage engine testing shows streaks of molten metal from a hot wall burn-through event

Almost immediately following the TROPICS-1 mishap, we made the strategic decision to focus the majority of Astra's resources on developing Astra's next-generation launch vehicle: Rocket 4. We focused the TROPICS-1 investigation on learning all that we could to inform the design and operation of this new, larger, and more reliable rocket. To that end, Rocket 4 incorporates key architectural choices (most notably, a different upper stage engine design and a different fuel) that completely eliminate the causes of this mishap. We have also introduced controls designed to eliminate a number of other potential failure modes (like FOD and helium ingestion) that the investigation concluded did *not* occur on the TROPICS-1 flight, but that Rocket 3.3 could have been susceptible to. For example, we are upgrading our helium diffuser design to prevent frothing in the propellant tanks and ingestion of helium into the engine.
