FORM 8-K

Astra Space, Inc.
(Exact name of Registrant as Specified in Its Charter)

Conclusion of TROPICS-1 Mishap Investigation

By Andrew Griggs, Head of Mission Assurance, and Adam London, Founder and Chief Technical Officer

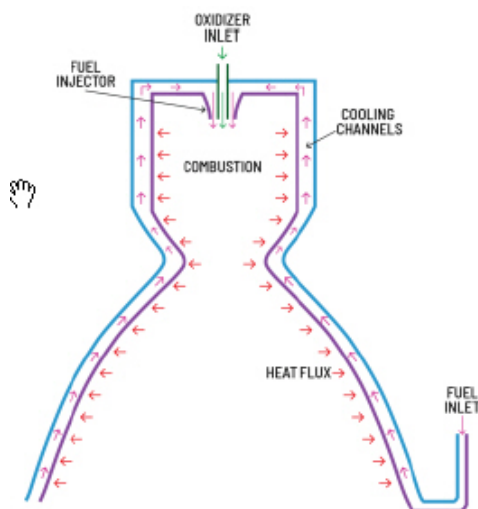
On TROPICS-1, a failure of the regenerative cooling system led to a chamber burn-through.

CAPTION: Schematic of regeneratively cooled rocket engine combustion chamber
